AGENDA OF THE
REGULAR MEETING OF THE CITY COUNCIL
CITY OF BIRCHWOOD VILLAGE
207 BIRCHWOOD AVENUE
WASHINGTON COUNTY, MINNESOTA
APRIL 26, 2011
WORKSHOP - 7:00 P.M.
REGULAR MEETING - to follow

EXECUTIVE SUMMARY – APRIL 26, 2011 WORKSHOP AND REGULAR CITY COUNCIL MEETING

Prepared for: City of Birchwood

On October 12, 2010, I performed an inspection of the Birchwood City Hall building located at 207 Birchwood Ave in the City of Birchwood Village. The purpose and intent of the inspection was to determine the condition and potential life expectancy of the building's major components, and recommend upgrades for the building where necessary.

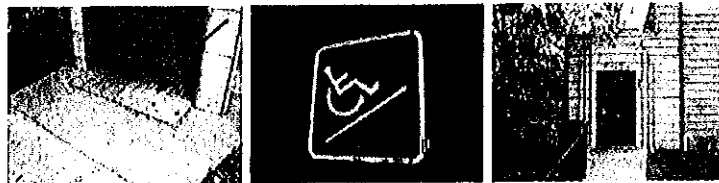
Entry Doors: Metal: The main entry door has a steep wood threshold installed to help smooth the transition from the sidewalk over the door threshold. Handicapped accessible doors should not have thresholds greater than 1/2" in overall height. The current threshold is steep and would be difficult for a person in a wheelchair to traverse.

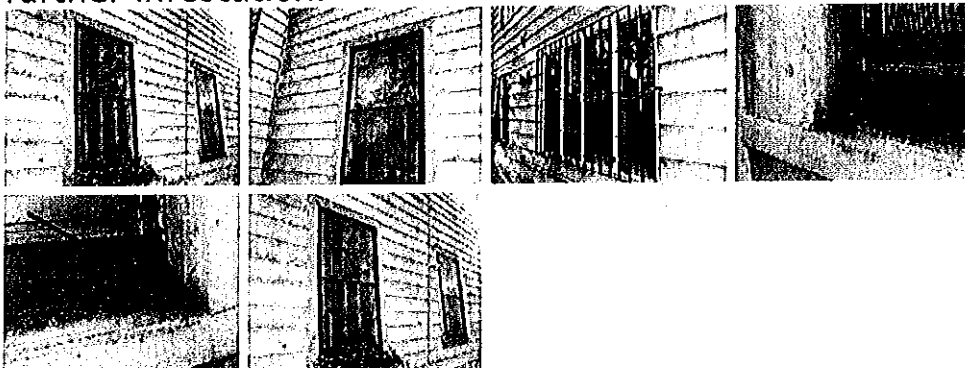
Windows: Wood Frame: It appears that bats are nesting in the siding and window jam area of one of the front windows. Pest control is recommended. Seal up gaps in siding to prevent further infestation.

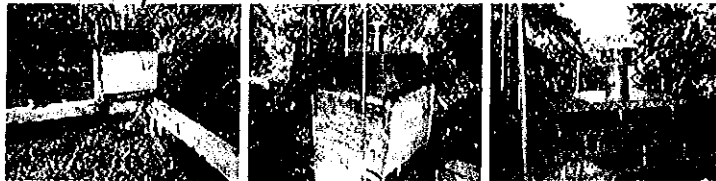
- 11. Acceptable
- 12. Marginal

Flue/Flue Cap: Clay with Aluminum Liner:
 Chimney Flashing: Galvanized: Recommend
 sealing or flashing joints where wood siding abuts
 the chimney brick.

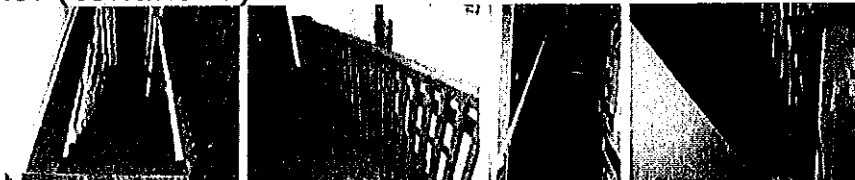
Stairs/Handrails: Wood Stairs with Wood Handrails: Wood stairs to the basement are the most significant barrier found with regard to accessible access for the handicapped. The Federal ADA standard accepts that there will be buildings that are existing non-conforming. The Americans with Disabilities Act (ADA) does not explicitly require that the office be made 100% accessible. ADA does require that any service provided or performed by the public office must be provided equally for those with disabilities.

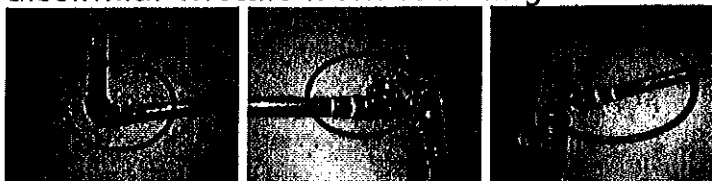
- 3. Marginal Water Lines: Galvanized & Copper: Inspection revealed some copper and galvanized water piping directly connected to each other. This condition can cause corrosion between the two dissimilar metals. Direct connections between dissimilar metals should be accomplished by using a dielectric union fitting. A dielectric union connects the two pipes while keeping the dissimilar metals from touching each other.

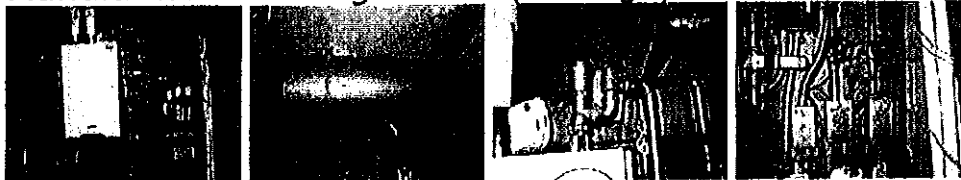
- 1. Acceptable Heating System Operation: Functional at time of inspection: Condition and installation of the boiler looks very good. This system is new and therefore has a good potential life expectancy.
- 2. Manufacturer: Triangle Tube (Prestige):

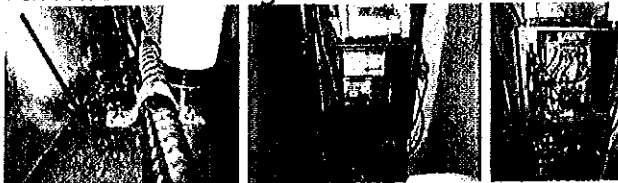
- 14. Marginal Heating System Operation: Functional at Time of Inspection:
Note: Mouse droppings were noted along the top edge of the furnace housing.

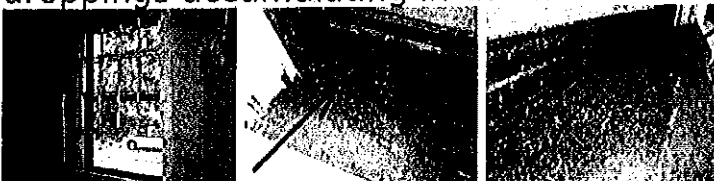
17. Marginal Windows: Wood Frame: These photographs show bat droppings accumulating in the window sill.

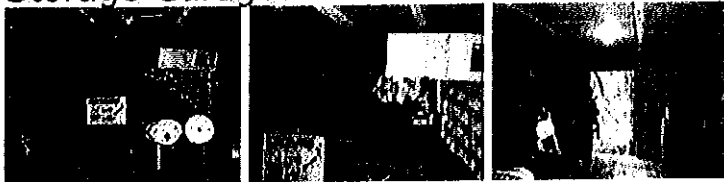
39. Marginal Signs of Mice in Storage Area: Paper towels at storage area are torn up by mice.

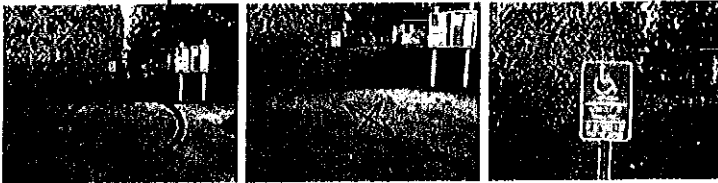
1. Driveway: Asphalt Parking Area: Inspection of the parking lot area reveals a handicapped sign posted near the main approach sidewalk. Handicapped parking spaces are typically posted with signage and striped on the parking surface. Striping the parking lot surface ensures that a clear area is provided adjacent to the accessible parking space. Parking spaces are typically 8 feet wide, with an additional 8 feet of clear space dedicated for handicapped parking access. It is recommended that a handicapped space be striped.

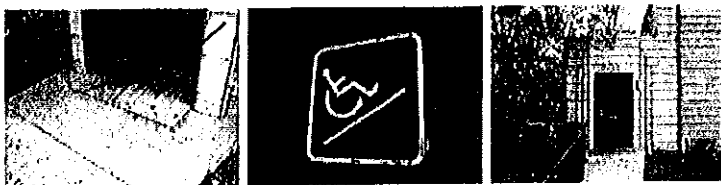
6. Entry Doors: Metal: The main entry door has a steep wood threshold installed to help smooth the transition from the sidewalk over the door threshold. Handicapped accessible doors should not have thresholds greater than 1/2" in overall height. The current threshold is steep and would be difficult for a person in a wheelchair to traverse.

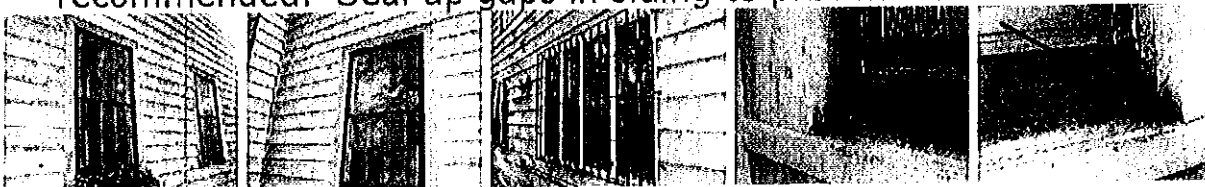
7. Windows: Wood Frame: It appears that bats are nesting in the siding and window jam area of one of the front windows. Pest control is recommended. Seal up gaps in siding to prevent further infestation.
